## CHAPTER IV

# Achieving Seismic Safety in Lifelines

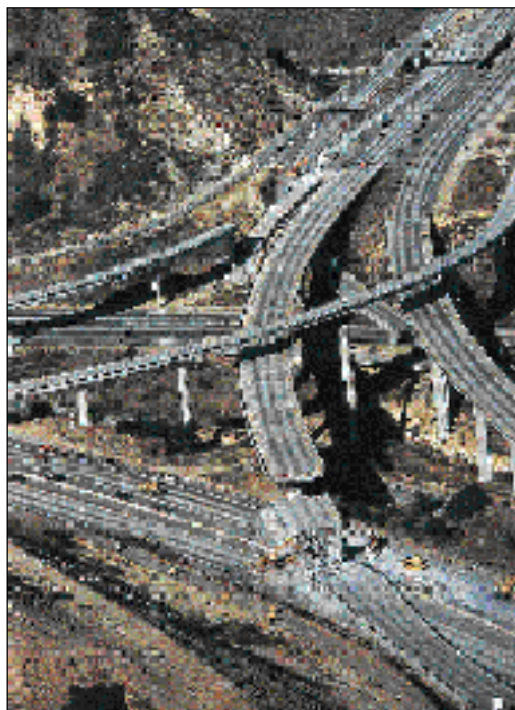
The interchange of State Route 14 and Interstate 5 (see Figure 68 for locations) was badly damaged in the 1971 San Fernando earthquake, but the two structures that collapsed in the Northridge earthquake, the North and South Connector overcrossings, were designed before 1971. At that time it was believed that improved hinge restrainers would be adequate to prevent collapse. Though they contain some pre-1971 design details, hinge restrainers were added to both bridges. During the Northridge earthquake, brittle shear failures in short stiff columns next to the abutments initiated the collapse of both bridges as shown in Figure 69. After the columns failed in shear and were crushed by the weight of the decks, the decks were pulled from their supporting abutments. As the decks fell, they failed by bending at the adjacent piers. These failures demonstrated that retrofitting such structures with hinge restrainers alone may not be adequate. Retrofitting the single-column piers to

prevent brittle shear, moment, and foundation failures may also be needed. Caltrans has incorporated this observation in the design of both retrofitted and new projects.

Figure 69. Two overpass collapses at the I-5/SR-14 interchange were started by failures in short, stiff columns.

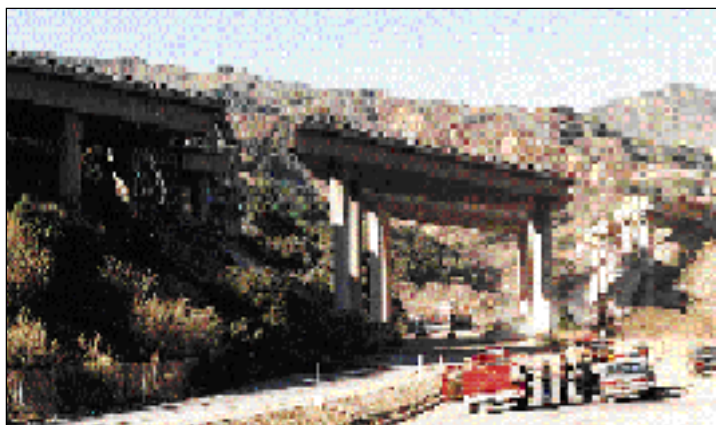
Although no steel-girder bridges collapsed during the Northridge earthquake, four bridges of this type, in a three-mile segment of Interstate 5 near the City of Newhall, sustained significant structural damage (Astaneh-Asl et al., 1994). These bridges are the Pico-Lyons Overcrossing, the Santa Clara River Bridge, the Valencia Boulevard Overcrossing, and the Old Road Bridge over the Santa Clara River.

Figure 70. Deck sections fell off their seats at the Gavin Canyon Undercrossing on I-5.

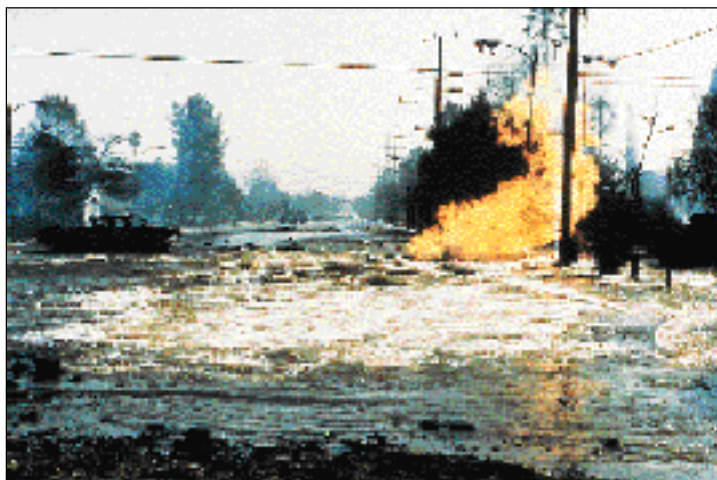
The Northridge earthquake also illustrated, as have previous earthquakes, that modern pipe of steel and other materials performs well even when subjected to intense shaking and moderate levels of ground displacement. Most of the problems in transmission pipe appear to have been related to weld failures in oxyacetylene-welded steel pipe installed before 1932, when welding procedures were inferior to those currently used (O'Rourke and Palmer, 1994). The natural-gas fire on Balboa Boulevard, Figure 71, was from an older pipeline in an area where significant ground deformation occurred; the resulting fire engulfed five nearby homes.

**Figure 71. Fire and flood produced calamity at Balboa Boulevard's ruptured gas and water mains.**

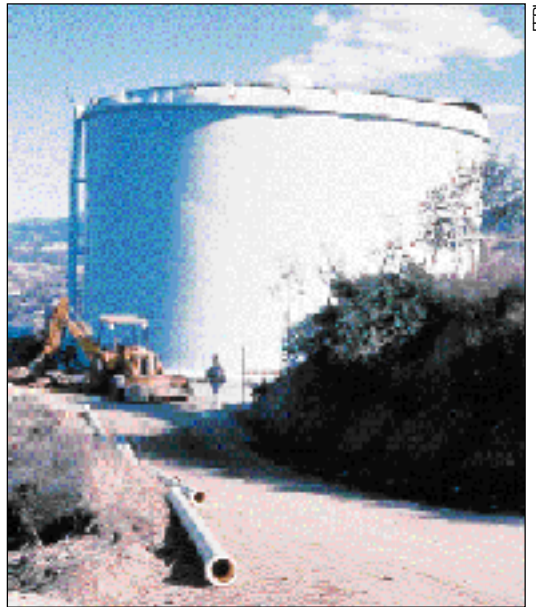
There was also extensive damage to older aboveground steel water tanks. In several cases, the entire contents of the tank were lost because of failures of inlet-outlet piping, which generally occurred because the ground shifted under the tanks. Other failures included buckling at the base of tanks, buckling of the shells, and roof damage. Because these storage facilities may represent the only immediate water supply for local systems, special measures must be employed to ensure their integrity after earthquakes (see Figure 72).

**Figure 72.** The walls of this water tank buckled; pipes ruptured and lost 800,000 gallons.

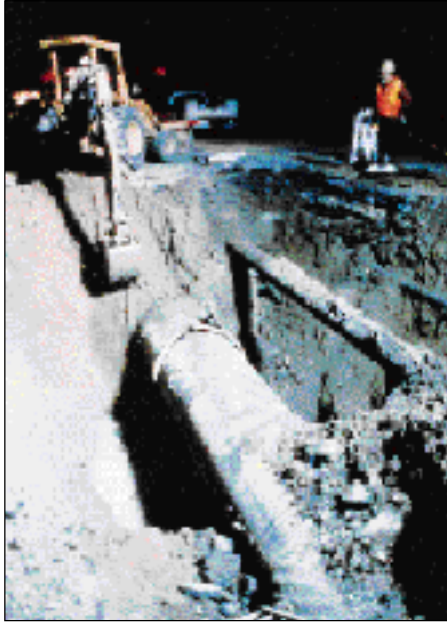
**Figure 73.** This four-foot-diameter water main under Balboa Boulevard buckled and ruptured when surrounding soils compressed it.
