## CHAPTER IV

# Achieving Seismic Safety in Lifelines

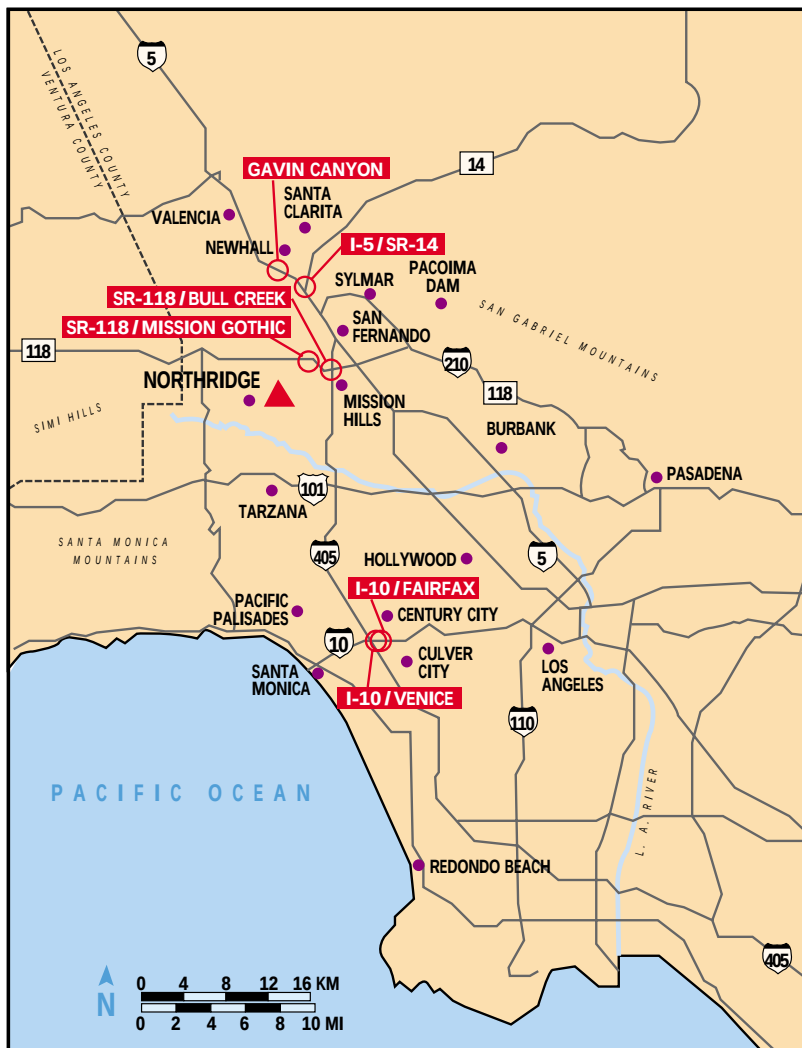
Figure 68. Location of collapsed overpasses.

The interchange of State Route 14 and Interstate 5 (see Figure 68 for locations) was badly damaged in the 1971 San Fernando earthquake, but the two structures that collapsed in the Northridge earthquake, the North and South Connector overcrossings, were designed before 1971. At that time it was believed that improved hinge restrainers would be adequate to prevent collapse. Though they contain some pre-1971 design details, hinge restrainers were added to both bridges. During the Northridge earthquake, brittle shear failures in short stiff columns next to the abutments initiated the collapse of both bridges as shown in Figure 69. After the columns failed in shear and were crushed by the weight of the decks, the decks were pulled from their supporting abutments. As the decks fell, they failed by bending at the adjacent piers. These failures demonstrated that retrofitting such structures with hinge restrainers alone may not be adequate. Retrofitting the single-column piers to
